SOIL SUITABILITY ESTIMATION FOR HOUSING PURPOSES IN LANDSLIDE-PRONE AREAS. THE CASE OF KARYA VILLAGE, PATRAS, W. GREECE

Koukis G.¹, Sabatakakis N.¹, and Lainas S.¹

¹ University of Patras, Department of Geology, Section of Applied Geology and Geophysics,
Laboratory of Engineering Geology, g.koukis@upatras.gr,
sabatak@upatras.gr, splainas@upatras.gr

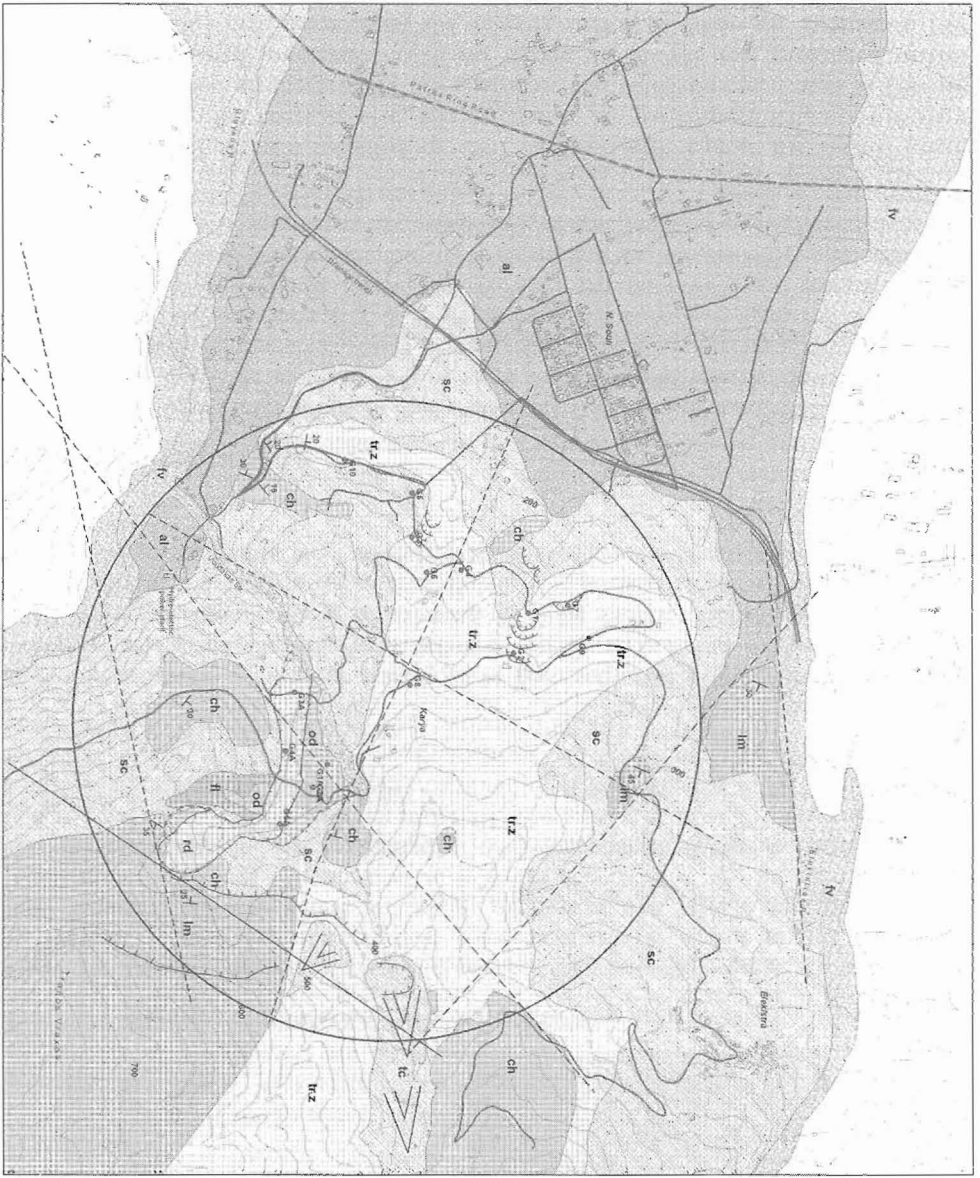
The various formations encountered were classified into ten engineering geological units according to their relative age and physical characteristics. The lower part of the normal sedimentary sequence includes schists and cherts of Jurassic age, which are covered by thin bedded Cretaceous limestones. A transition zone is developed above the limestones including limestones, shales, scherts and marls, leading to the typical flysch sediments. Clastic deposits including scree and debris overlay bedrock materials. The hillslopes around Karyia village consist mainly of scree and transition zone intensely fractured materials, whereas in N. Souli downslope area feature Pleistocene and Holocene deposits. Cherts and limestones typically outcrop at the mountaneous area near the SE margins of Karyia village (Fig. 2).

Figure 2 – Engineering geological map of Karya and Neo Souli villages area

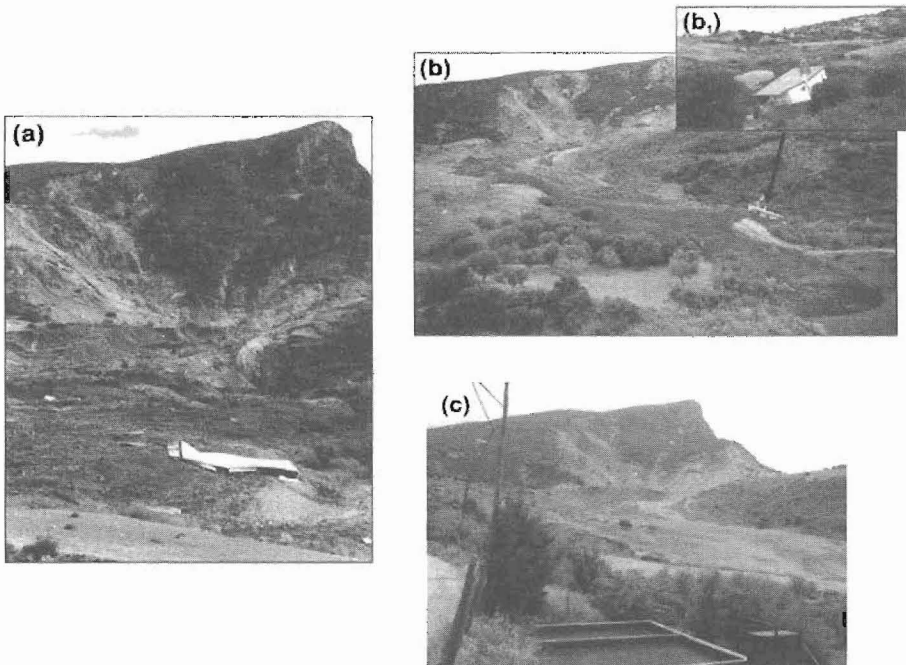
The first significant failure was recorded in 1962, a year with almost the double annual precipitation records than the previous year, and resulted to the partial destruction of old Karyia village which was founded on the head of the landslide. The landslide reactivated in February 1999, where a sudden mass movement occurred during an intense and prolonged rainfall. According to precipitation data recorded by the gauging station of Patras the February's 1999

rainfall was 250 % greater than the mean monthly value. The event was a debris flow followed by a translational multiple slide involving recent debris, older sliding materials and weathered zone of Flysch. The main road connecting nearby villages was destroyed, while the streamlet at the base of the gully was blocked by debris materials forming a 4-meter deep lake.

In December 2001, an intense rainfall of about 94 mm in less than 24 hours resulted to a sudden failure of a large volume of debris material that triggered a new extensive landslide. The debris flowed rapidly on the slope causing a “tongue” of saturated material to slip down and overtop the slope face. A translational slide was also activated in the lower part of the landslide. A newly constructed house founded inside older sliding materials was totally destroyed, while the main road connecting nearby villages was destroyed for a second time.

Figure 3 – Karya Landslide (a) 1999 event, (b) 2001 event (b₁) damaged house and (c) current condition

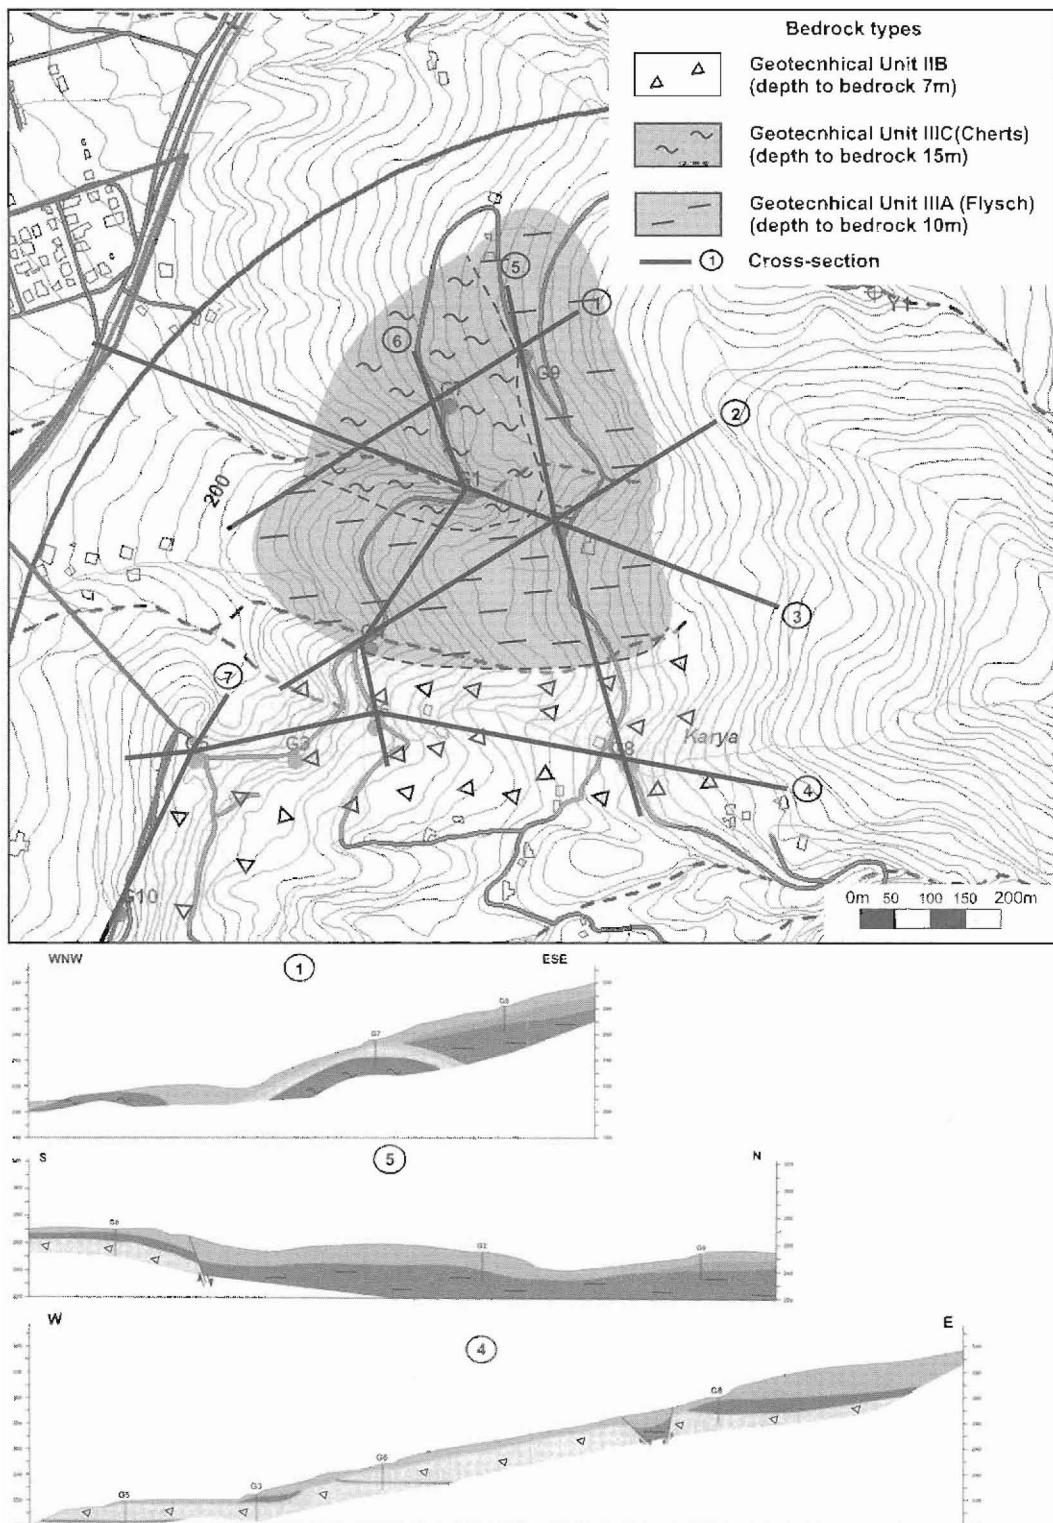
In order to get a general and simplified 2-D geotechnical model of the study area several geotechnical profiles and cross sections were drawn. Figure 4 illustrates the distribution of bedrock along with some representative Geotechnical cross section of the study area. As shown in Figure 4, in the north part of the study area Chert of Flysch bedrock is encountered in a depth between 10 and 15 m covered by relatively thick surfacial materials, whereas materials of Geotechnical Unit IIB dominate in the south part covered by a 7-meter surfacial cover.

Figure 4 - Geotechnical cross-sections and distribution of bedrock types

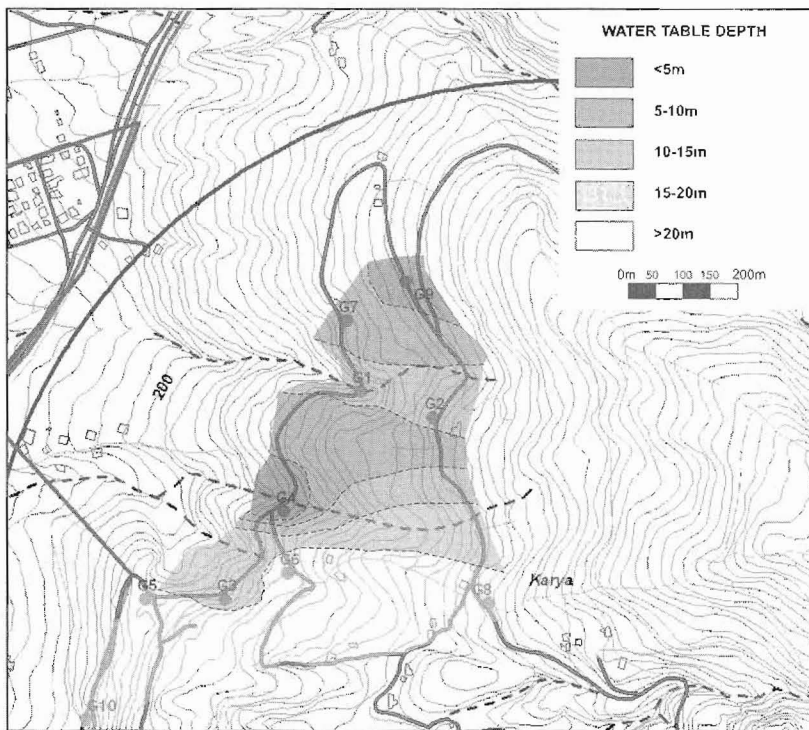
Water table depth measurements saw differential groundwater conditions between the north and the south part of the study area. Moderate to high water table (less than 10m from surface) was measured in the north part sometimes near soil surface. On the other hand, the south part is characterized by low water table (more than 15 m from surface) or absence of water up to 20 meters (Fig. 5). The impermeable Flysch or Chert bedrock contributes to high water table conditions, whereas the intensely fractured and more permeable materials of Geotechnical Unit II are characterized by low water table or regional dry conditions.

Figure 5–Water table depth distribution

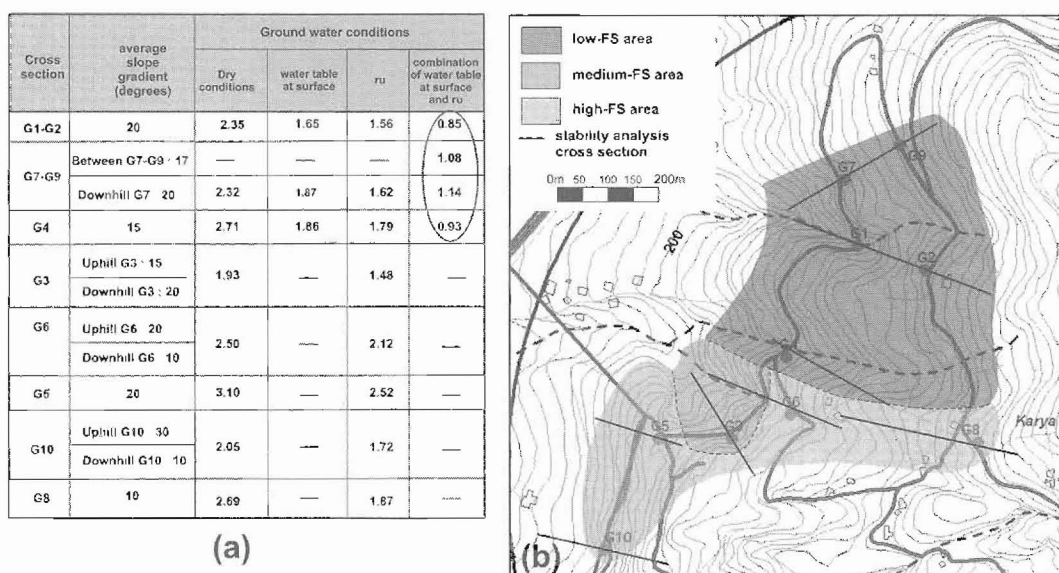
As shown in Figure 6, low Safety Factor values were computed in the north part of the area so, according to the results, it is more susceptible than the rest region for instability problems under extremely high pore-water pressure conditions, caused by heavy and prolonged rainfalls.

Figure 6 – (a) Slope stability analyses results (b) distribution of estimated Safety Factors

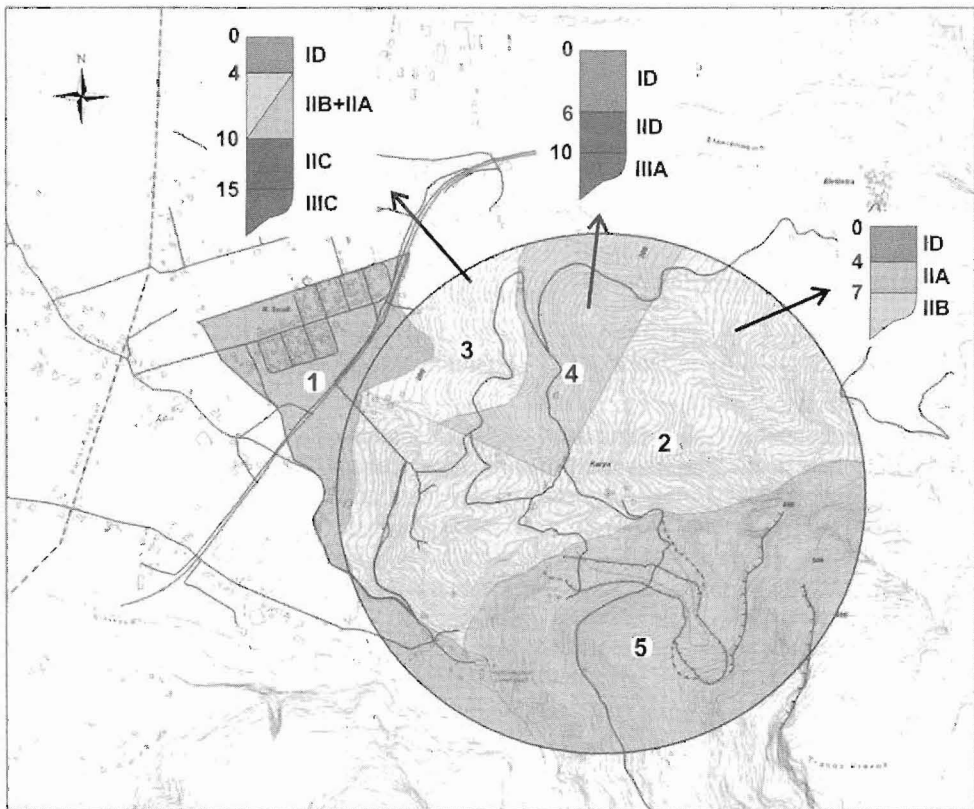
Based on the engineering geological and geotechnical investigation the village area was finally divided into five zones according to the encountered ground for housing purposes (Fig. 7):

- Zone 1 was classified as suitable for housing since it is relative flat, it consists of stiff recent Pleistocene-Holocene deposits and has not instability problems.
- Zone 2 consists of coarse grained Unit IIB materials covered by up to 5 m-thick scree and weathered materials. It is characterized by low water table, absence of instability problems and has relatively high Safety Factor values according to slope stability analyses.
- Zone 3 consists of weathered Chert bedrock covered by about 4-meter thick surfacial materials and 11-meter thick various intensely fractured materials of Unit II. It is characterized by high water table, small-scale instability problems and lower Safety Factor values according to slope stability analyses.

- Zone 4 consists of weathered Flysch bedrock covered by up to 12-meter thick surficial scree materials. It is characterized by high water table, small-scale instability problems and has the lower Safety Factor values according to slope stability analyses.
- Zone 5 represents soil formations and engineering geological conditions unsuitable for housing, due to active Karya landslide inside it.

Figure 7 – Soil suitability division in village area and typical geotechnical columns of the three zones to which housing requirements were specified

Several housing requirements and suggestive guidelines for housing were specified for Zones 3, 4 and 5 regarding foundation, excavation and drainage. Zone 4 was considered as the worst among them for housing. Specified requirements and guidelines aim to prevent from instability phenomena caused by static loading, ground water conditions or excavation. The general guidelines suggest:

- Avoidance of surficial fine-grained soils of Unit ID as foundation materials
- Avoidance of mechanical excavation in slopes with inclinations exceeding 35%. For slopes inclined less than 35%, a 3m maximum height of excavation is suggested supported with retaining walls.
- Surface water runoff with net of diversion ditches.
- Construction of interceptor drains parallel to the road sides.
- Protection and preservation of streamlets' flow zones.
