## SLOPE STABILIZATION ON CHALKOUTSI – DILESI ROAD, AT PIGADAKIA LOCATION, ATTICA PREFECTURE

### Abstract

*A series of ongoing landslides occurred at the steep coastal slopes at Pigadakia location, on the road connecting Chalkoutsi and Dilesi towns, at NE Attica. These landslides caused severe disruption on local traffic.*

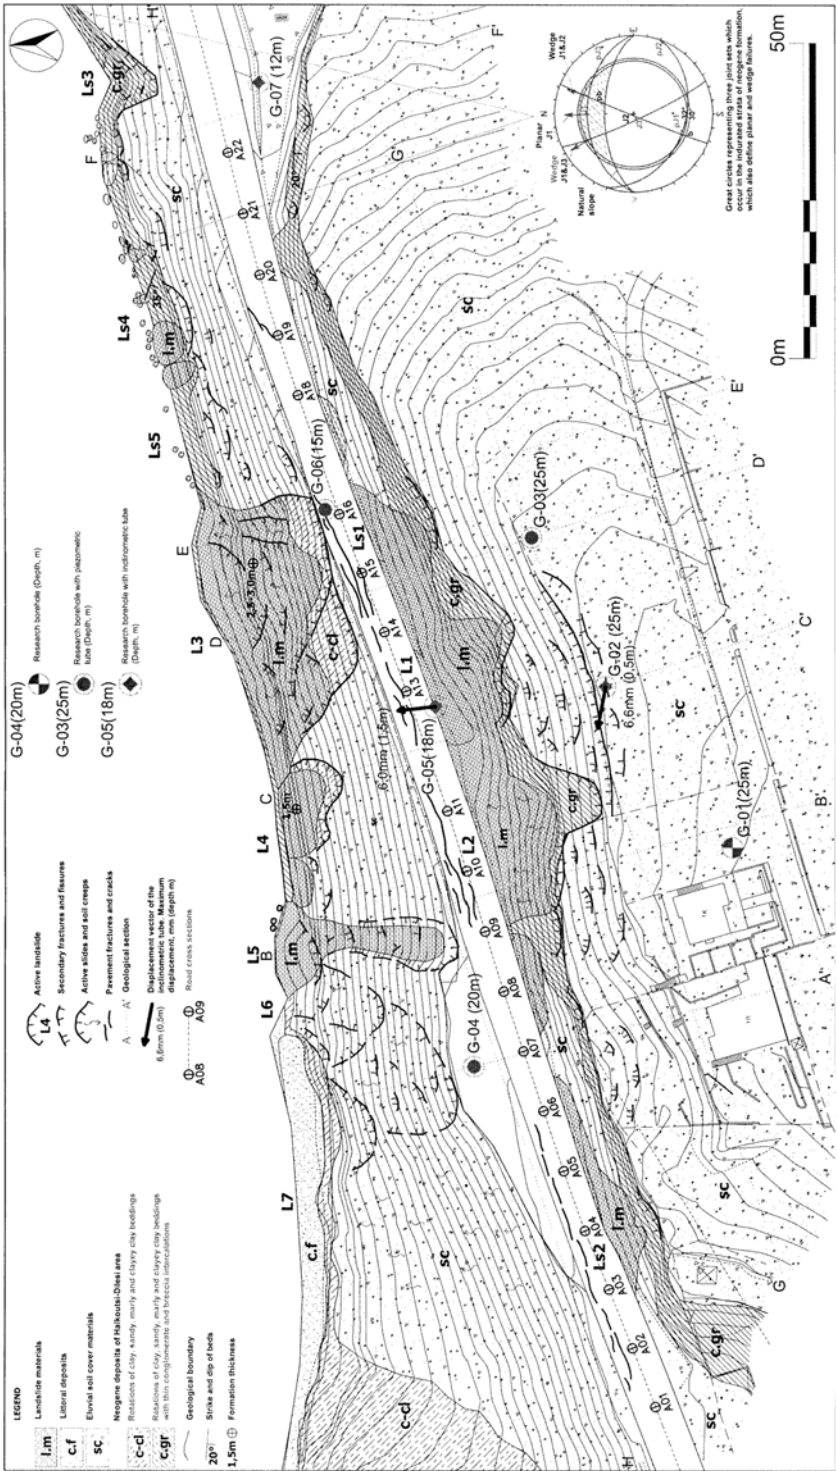
Fig. 1: Geological map of the project area.

For descriptive purposes the failures that occur along the coastal forehead are divided into the upper part and the lower part in relation to the road (Fig. 1).

The first main failure (L1) pertains to soil material fracture and sliding with head scarp altitudes from +28 to +30 and toe at the road level at +16. The range of fracture is 18m while the accumulation of sliding material, at the road level, has 21m range. The second main failure (L2), which is the most important, is located about 7m to the west from the previous one, with head scarp altitudes from +31 to +35 and toe at the road level at +19, has 32m range and analogical accumulation range at the toe.

25/5/2006 and in 29/6/2006. The displacement vectors measured in the above time interval (approx. 3 months) along with the maximum recorded displacement (in mm) and the depth, in which it was observed, are presented in Fig. 1. During that period, the recorded displacements were small (~5-6mm) inside the error limits of the instrument and were presented in small depths G-02: 0,5m, G-05: 1,5m, G-07: 0,5m).

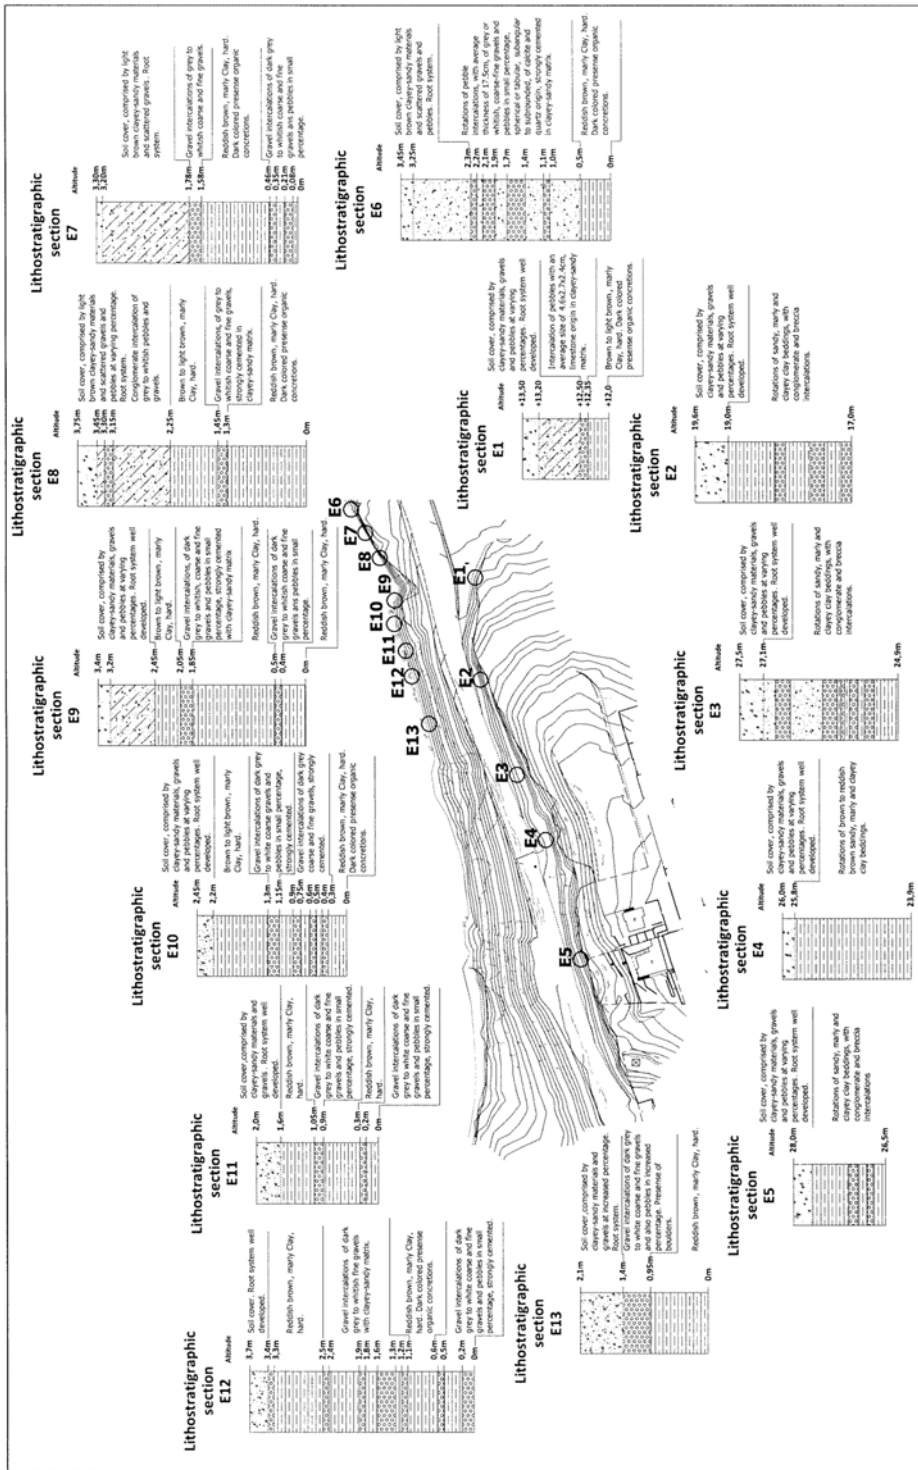
Fig.2: Lithostratigraphic sections of the natural slopes.

The Neogene substratum consists of brown-red colored rotations of clay, sandy, marly and clayey clay (c-cl) beddings, with thin conglomerate and breccia (c.gr) intercalations (Fig.1, Fig.2 and Fig.3). The lower horizons at sea level seem hard and cohesive, while the upper horizons are semi-cohesive to loose with cohesive beddings insertions. The persistence of the discontinuities crossing the formation is greater than 3m, with planar, slightly rough surfaces, closed or with apertures up to 5mm, walls slightly weathered, void or with reddish clayey material and dipping at N, NW and SW directions with dips of 40°, 85° and 80° respectively, forming planar and wedge failures (Fig. 1). Within the fine material appear sparse pebbles, small-sized breccias and fossil bones from mammals.

structures formed by the surface water runoff. The Neogene substratum appearing along the natural and man-made slopes is presented in detail at the lithostratigraphic logs of figure 2.

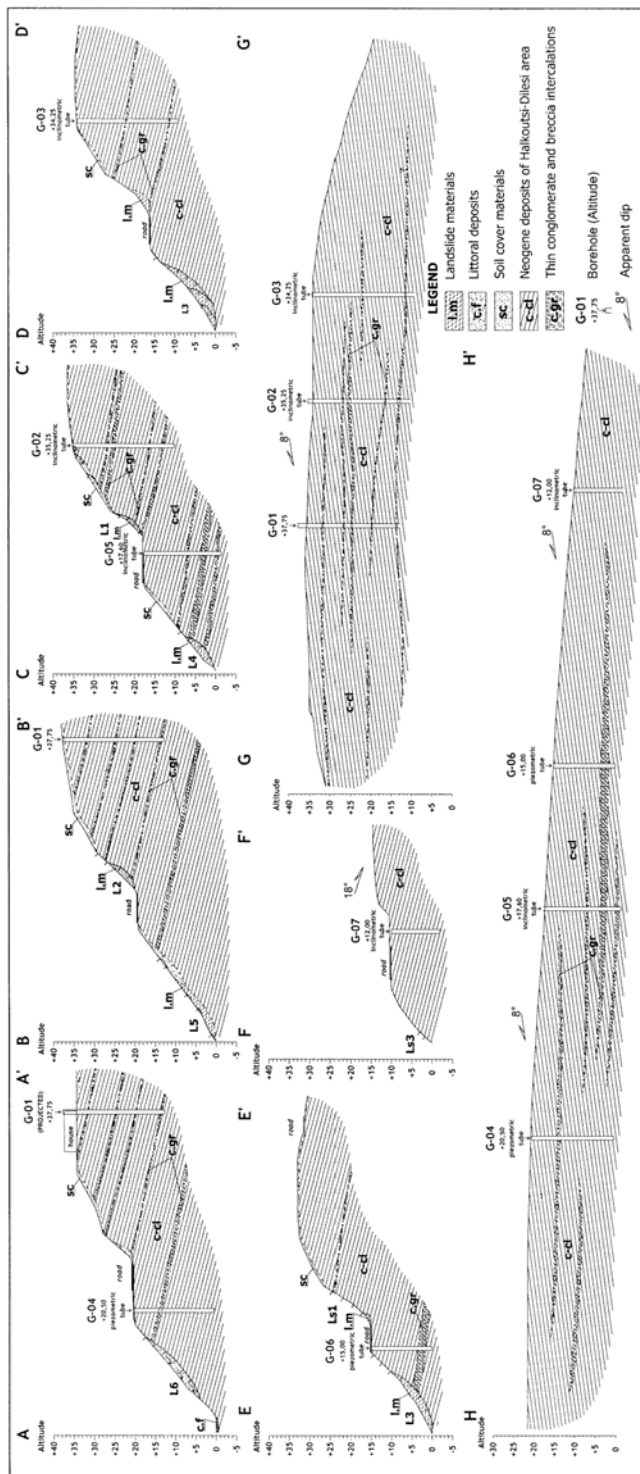
Fig. 3: Geological cross sections.

The conglomerate and breccia intercalations are continuous, planar or slightly undulating, parallel or sub-parallel, with distinct bed boundaries. They comprise of gray, brown and whitish gravels with an average size of 0.036x0.022x0.018m and limestone pebbles, strongly cemented with light brownish to red brownish clayey-sand material. Coarse materials are poorly to very poorly sorted, with gravel shapes being spherical to tabular with subangular to subrounded roundness, while sand granules, of quartz origin, are also being spherical to tabular with angular to subrounded roundness. The conglomerate and breccia intercalations exhibit depositional structures of normal graded to composite bed sequences (Fig. 2 and Fig.3).

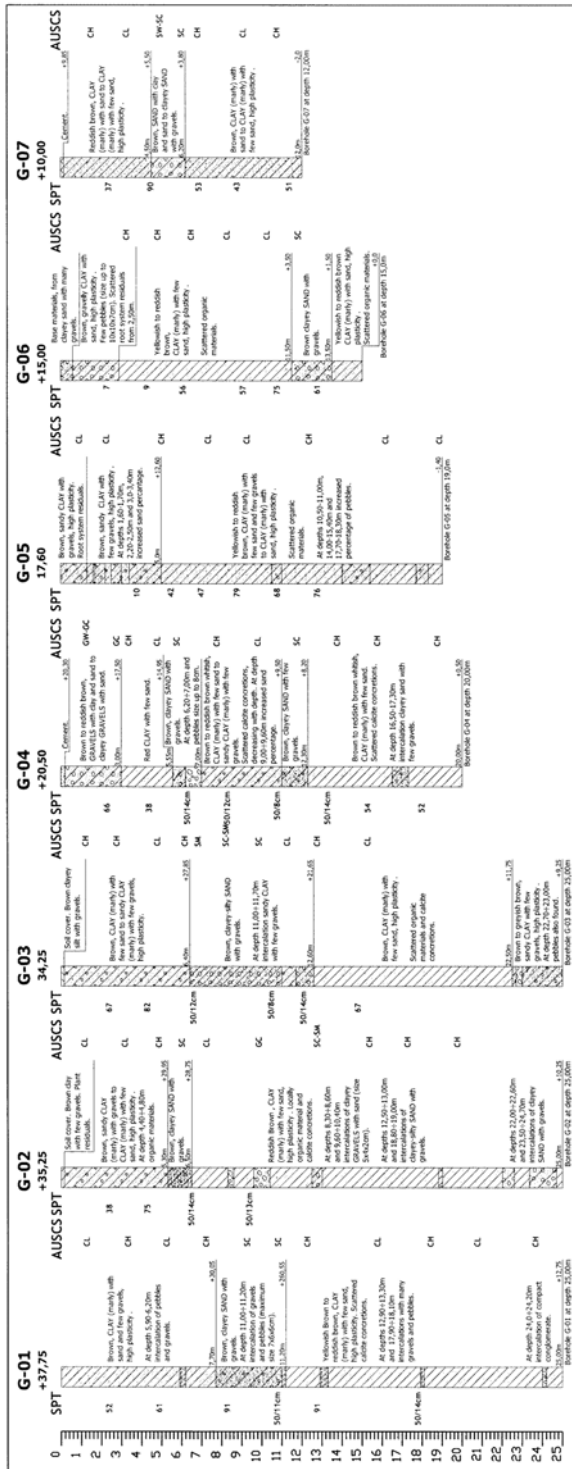
Fig. 4: Boreholes logs

According to the results of the investigation works the area is covered by formations of very hard clays of high plasticity that in their majority are unsaturated and include preexisting discontinuities, fissure planes and slickensides. In the clayey formations in various depths, dense sand-gravel layers are present, constituted mainly from clayey gravel with sand to clayey sands with gravel.

The observed slides in lower and upper slopes of the road are caused by the gradual diminishing of the shear resistance of hard clayey formations due to the progressive loss of the cohesion component of the shear strength, caused by the combined action of increased moisture content and displacements. The increase of the moisture content is caused by the infiltration of surface waters to the interior of their mass and is facilitated by the presence of the preexisting discontinuities into the body of the clay. The steep excavation slopes ( $45^{\circ} - 55^{\circ}$ ) applied and the gradual loss of the shear strength from peak values to the fully softened values (Skempton, A.W., 1948, 1964, 1967, 1977; Terzaghi, K., Peck, R.B., Gholamreza, M., 1996) led to an increased tendency for slope displacements. In order to ensure the long term stability of the slopes an excavation with milder slopes ( $\sim 25^{\circ} - 30^{\circ}$ ) was necessary. Regarding the lower slopes, their instability is influenced by the additional continuous erosion of the slope toe by the sea waves causing a continuous loss of their support.

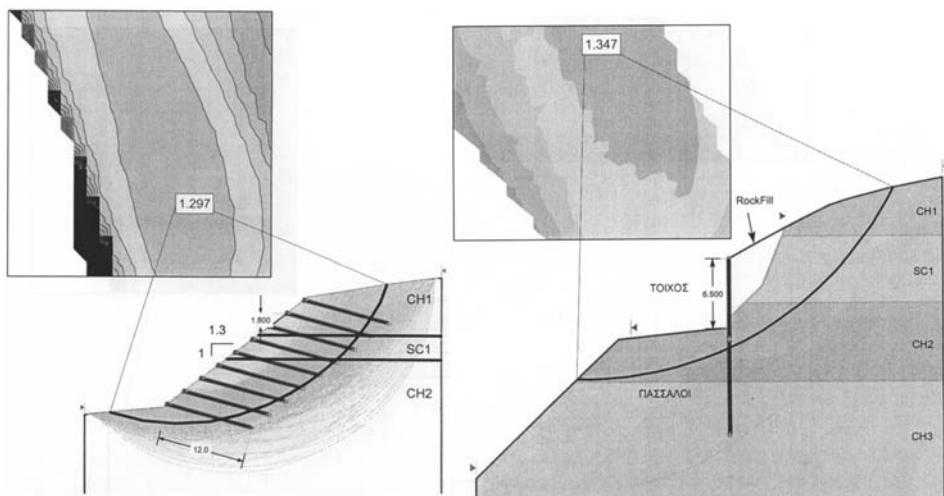
**Fig. 6:** Circular surfaces examined using the modified Bishop method of slices at the A09 section for remedial measures according to solution A (left) and at section A18 for remedial measures according to solution B (right).

For the determination of the slip surface with the smaller factor of safety, a large number of circular surfaces (as observed and in the actual slides) were examined covering the entire slope (the upper with the proposed measures and the lower at its present state), using the modified Bishop method of slices. The minimum factors of safety (F.S) calculated with application of the stabilizing measures of Solution A, are 1.30 and 1.02 for static and seismic loads respectively at section A09 and 1.34 and 1.04 for static and seismic loads respectively at section A14.

The minimum factors of safety calculated for solution B, by examining a large number of potential circular slip surfaces covering the entire slope (the upper with the proposed measures and the lower at its present state), using the modified Bishop method of slices, are 1.57 and 1.09 for static and seismic loads respectively at section A07, 1.29 and 1.00 for static and seismic loads respectively at section A13, 1.34 and 1.04 for static and seismic loads respectively at section A14 and 1.35 and 1.00 for static and seismic loads respectively at section A18.

The stabilization measures of the upper slopes according to alternative solution A (Fig. 6), in more details comprises:
