PROTECTION MEASURES AGAINST GEOLOGICAL FAILURES, DURING THE CONSTRUCTION OF THESSALONIKI - KAVALA SECTION OF EGNATIA HIGHWAY IN N. GREECE

Chatziangelou M. and Christaras B.

Abstract: The present paper refers to the major part of the Egnatia highway, about 100km long, which connects Thessaloniki and Kavala cities, at north Greece. Actually, it is divided in three parts: i) Nymphopetra-Aasprovalta, about 40km long, ii) Asprovalta-Strymonas, about 20km long and iii) Strymonas-st. Andreas, about 40km long. The highway has already been constructed. Driving from the west to the east, the highway, at the beginning of Nymphopetra-Strymonas part, passes nearby Volvi lake, at the foot of Vertiscos mountain. Easterly, it passes through Kerdillia mountain, Strymona's river and it leads to Pangeo's mountain, ending through Symbol mountain. The highway also passes through five tunnels; i) Vrasna tunnel, which is located at Nymphopetra-Asprovalta's part, ii) Asprovalta's tunnels, which are three tunnels locating at Asprovalta – Strymona's part and iii) Symbol tunnel, which is located at the last Strymonas – st. Andrea's part. The paper describes the support measures against geological failures

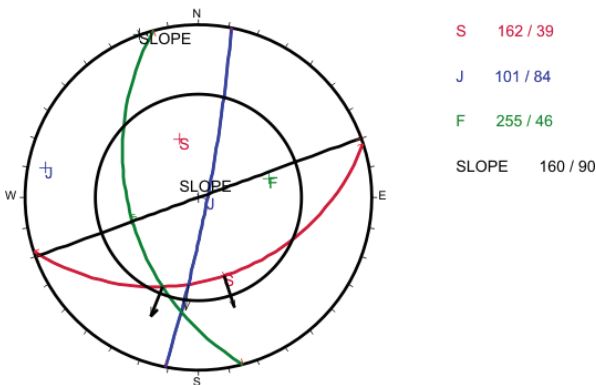
Slope “O11”, ch.2+500 - ch.2+800

The slope “O11” consists of lake deposits. A fault of 255/46 cuts these deposits. The lake deposits may slide along the direction of the bedding 162/39. Two potential wedges were formed by; i) bedding 162/39 and fault 255/46 and ii) joints 101/84 and bedding 162/39. The sliding took place at SSW direction (Fig.2). Also, the critical slip cycle was estimated using slope geometry of 15m high and slope inclination of 90°. The radius of the critical circle was estimated 15m and the safety

Fig. 2. Potential sliding along the slope “O11”.

factor was calculated 3, for saturated conditions.

In order to protect the slope against sliding, a slope inclination of 34° was proposed. Using the proposed inclination, the radius of the critical circle was estimated at 29m and the safety factor was calculated 5 in saturated conditions.

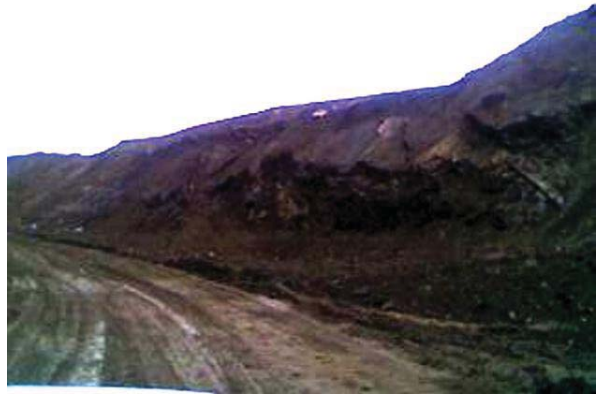
The slope is placed on the right hand of the road and consists of weathered gneiss with pegmatitic intercalations (Fig.3). The poor quality of the rock mass, together with the unfavorable orientation of the schistosity, affected the stability of the slope and caused extensive sliding. Two types of probable sliding were determined, according to our investigation. The first one referred to slope sliding along the schistosity with direction of 221/36, and the second one referred to potential wedge sliding. There was a potential unstable wedge, which was formed by the surfaces of a fault with direction of 195/60, the schistosity with direction of 221/36 and the joints with direction of 357/52.

Fig. 3. Slope placed on the right hand of the road.

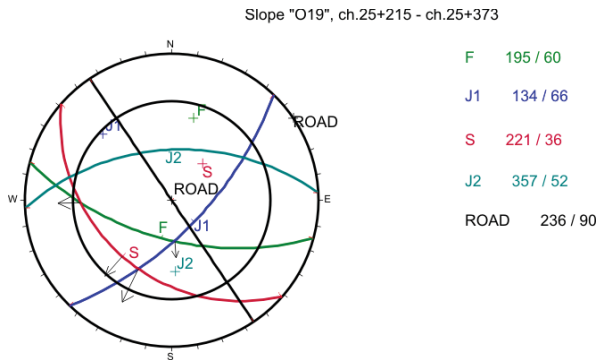
According to test Markland, 1972, the schistosity of the gneiss with direction of 221/36 was parallel to the strike of the slope causing planar sliding conditions. Two approaches were considered, in order to protect the slope from sliding (Fig.4).

protect the slope from sliding. This was because the plunge of the schistosity was located inside the area, which was bounded from the slope plane and a friction angle equal to 21° . So, if the average inclination would be less than 34° , the safety was ensured.

Fig. 4. Potential sliding along the slope “O19”.

- i. Change of the slope inclination, or
- ii. Change of the highway direction.

Considering that the second solution was almost impossible, the slope geometry was studied using the limited inclination in order to ensure the stability without changing the road design. Using an inclination more than 36°, ex. 45° (1:1), we could not

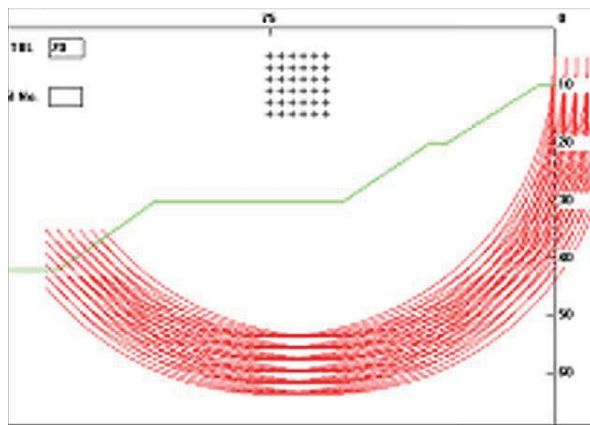
Gneiss was easily weathered, mainly by rainwater and salt spray coming from the sea, losing important part of its cohesion behaving as a soil. So, for

Fig. 5. Circle sliding analysis and safety factor of slope “O19” after the embankment’s construction , in unsaturated conditions.

the stability of the slope, a critical slip cycle was estimated for proposing the proper slope geometry. The slope stability was performed using unit weight of gneiss equal to $2,65 \text{ gr/m}^3$, friction angle equal to 22° and no cohesion.

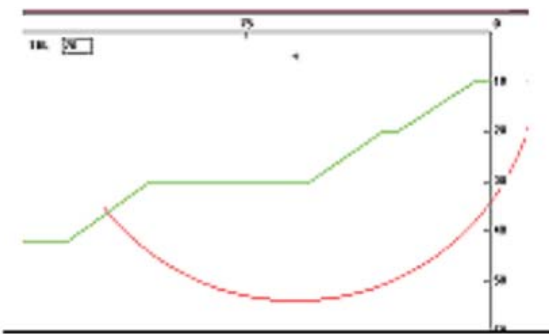
Fig. 6. Critical slip circle and safety factor of slope “O19” after the embankment’s construction , in saturated conditions.

Two benches, 10m high were proposed, with inclination of 34° (V : H = 2:3). Low vertical benches, having width equal to 5m and height of 2,5m – 3,25m, designed to be created at the site of the embankment, so as the friction between the embankment and the slope to be increased. Using the geometry above, the slope in study was stable in dry conditions (S.F. = 2) and almost was unstable (or limited stable) in saturated conditions (S.F.=1) (Fig.5,6). After the construction of the embankment, the safety factor, in dry conditions, was estimated equal to 2 and in saturated conditions equal to 1 (instability).

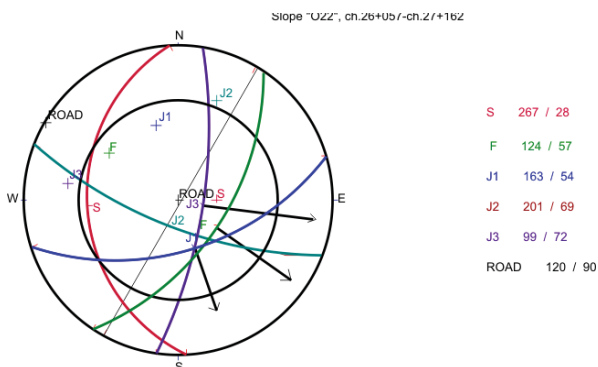
The slope “O22” consists of very cracked and totally weathered gneiss (RQD = 5%), covered by sand formation of Pleistocene. The quality of gneiss of the slope was poor as the rock mass was very weathered and absolutely cracked (RMRbas=28). For this reason, rock mass behaved as a soil. According to the SMR classification system, the slope was unstable. Studying the stability of the slope, the gneiss rock mass slipped along; i) the fault 124/57 and ii) the joints of 99/72. Potential wedges were also formed by joints 201/69,

99/72 and joints 124/57 parallel to fault. Sliding took place at SSE direction.

Fig. 7. Possible sliding along the slope “O22”.

Terraces inclined at 45° were proposed to form the “O22” slope in order to be protected from planar sliding. The maximum height of the slope was about 50m. Taking into account that the slope consists of totally weathered gneiss ($\gamma=2,65\text{gr/cm}^3$, $\varphi=26^\circ$, $c=0$), there was a potential cyclic sliding (Fig.7). But according to slope stability analysis in saturated conditions, the slope was stable as the calculated safety factor of the critic circle was 7.

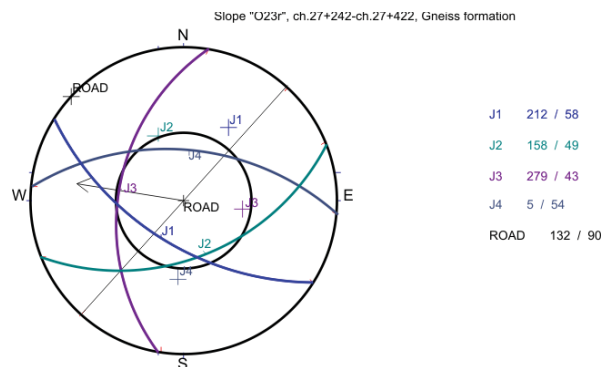
According to the SMR classification system, the marble formation on “O23r” slope was moderately stable, although the gneiss formation on the same slope was stable. The “O23l” slope was moderately stable. According to stability analysis of the “O23r” slope, the type of probable sliding was; i) a planar sliding of gneiss rock mass along the joints directed to 279/43 and ii) a potential wedge sliding at west direction. The planes of joints 212/58 and 279/43 formed the wedge (Fig.8). The marble rock mass sliced along the joints of 287/71 (Fig.9). As the rock mass was slightly weathered, there was no possibility of cyclic sliding. The gneiss rock mass of the “O23l” slope sliced along the planes of joints 210/64. A potential wedge, being formed by

Fig. 8. Possible sliding on gneiss at slope “O23r”.

In order to protect the slope, against sliding, an inclination of slope equal to 45° was proposed.

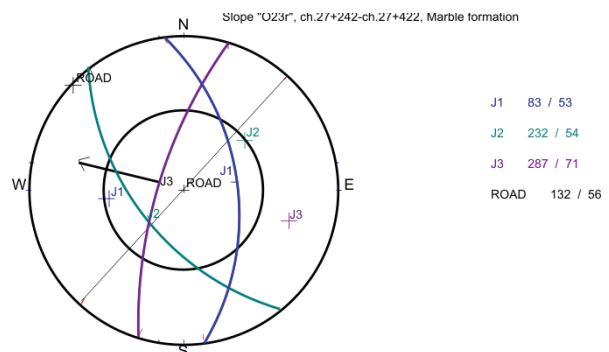
Fig. 9. Possible sliding on marble at slope “O23r”.

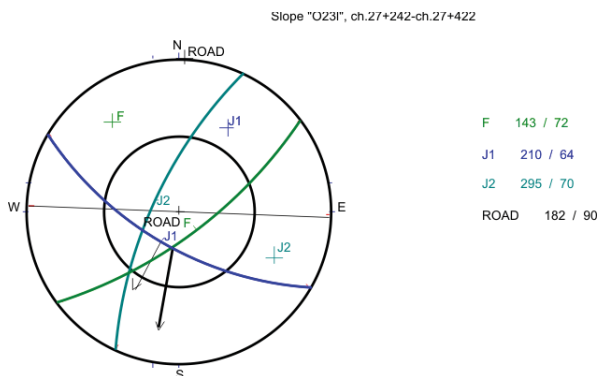
the joints of 210/64 and joints parallel to fault 143/72, sliced at South direction (Fig.10). As the rock mass was slightly weathered there was no possibility of cyclic sliding.

Fig. 10. Possible sliding along the slope "O231".

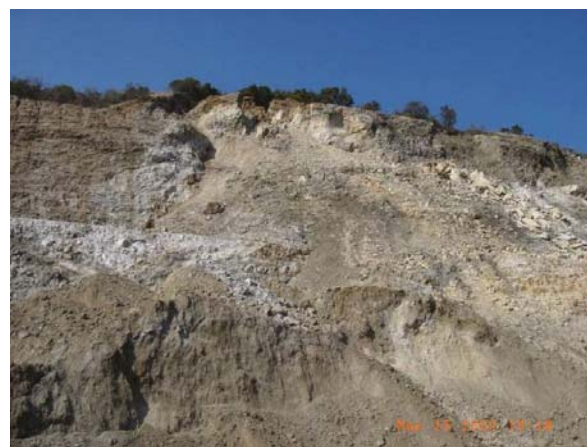
The slope, 60m high, consists of medium to high weathered, cracked biotitic gneiss. The water of a short rainfall decreased the safety of slope and created landslide. The landslide was bounded at the half-formed part of the slope (Fig.11). Rock mass quality was poor (category IV). Tension crack

Fig. 11. Landslide at ch.9+700 along the road.

caused circular soil sliding. The critical circle in unsaturated conditions, was 50m deep and the safety factor was calculated 1,66. In saturate conditions, caused by rainfall, the safety factor was 1,16. A short rainfall, which had taken place on March 2002, created a landslide of the half part of the slope, which was just excavated using a beginning geometry. The slope consisted of small rock blocks. A cyclical sliding of loose material was bounded at east side of slope, where was a fault surface (115/65) and at west side of slope, where was a long sliding surface (120/76) (Fig12). Rainfall was the main cause of landslide at the safety factor (1,16) in saturated conditions was ultimate (Chatziangelou and Christaras, 2005).

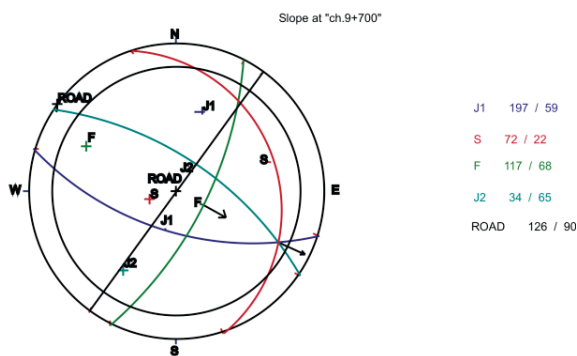
Fig. 12. Possible sliding along the slope at “ch.9+700”.

For landslide restoration and support, dips of downstairs were proposed to be smaller (height/width=1/1.5 and 1/1) than dips of upstairs (height / width = 2 / 1). Using this new geometry, the safety factor was 25% higher (SF = 2.08) at unsaturated conditions and 35% higher (SF = 1,57) at saturated conditions than using the beginning geometry. The benches of the slope were designed about the same length so as the length did not affect the safety factor and pore pressure. Thus, safety factor depended only on inclination of benches. According to the new geometry, big dips were formed downstairs and small ones were formed upstairs. When the height was also increased, restrained powers were increased and sliding powers were decreased. So, the safety factor of every part was progressively increased downstairs to upstairs making slope stable (Fig.13,14).

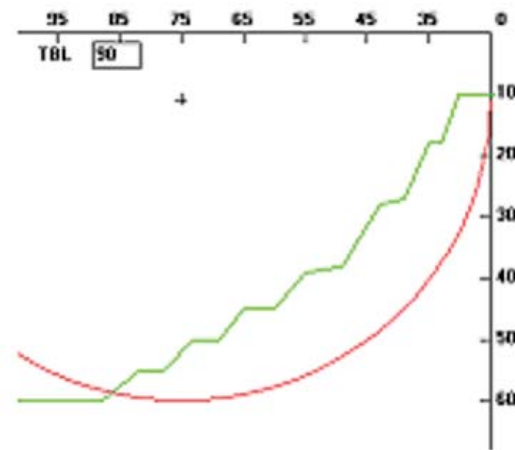
Fig. 13. Critical slip circle and safety factor of slope at “ch.9+700” using the proposed geometry in unsaturated conditions.

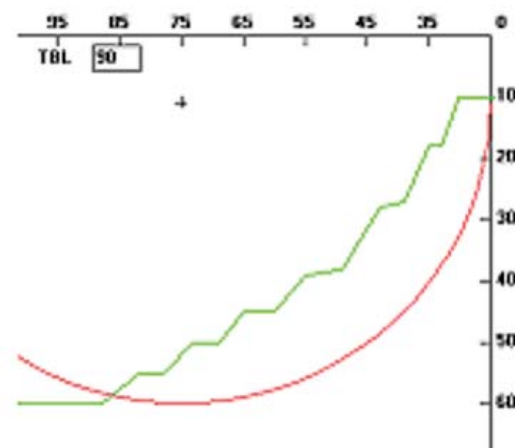
Fig. 14. Critical slip circle and safety factor of slope at “ch.9+700” using the beginning geometry in saturated conditions.

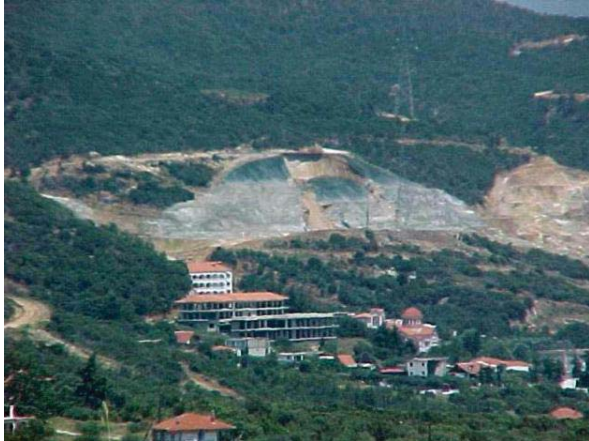
An open trench was planed to be constructed at the southern part of the Asprovalta tunnel II in order to replace the right bore of the tunnel (Fig.15). The excavation was performed from the upper parts to down slope. The geological formations, which were analyzed during the excavation were folded gneiss with joints of north and southeast directions, folded marble with joints of west and southeast directions, folded amphibolite, whose schistosity was

Fig. 15. The landslide in study.

According to RMR classification system, the rockmass quality was characterized as poor ($RMR_{bas} = 22-40$, $RMR = 3-17$). There was a part of slope between ch.10+570 and ch.10+640 consisting of amphibolite and marble formations with better rock mass quality ($RMR_{bas} = 42-49$, $RMR=24-35$) than the rest part of the slope. According to SMR classification system, the excavation of the slope was very unstable and extensive failures were expected.

The formation of the upper three benches (4th, 3rd and 2nd) was just completed when an extensive landslide took place. The landslide was placed between ch.10+533 and ch.10+620. The sliding of the trench took place. The sliding of wedge between ch.10+600 and ch.10+620, located in the marble of the 2nd bench, caused the beginning of landslide. The sliding occurred along the schistosity plane 195/39 and joints 278/76. The sliding of the wedge activated new sliding in the neighbor part between ch.10+533 and ch.10+600. The new sliding took place along the direction of gneiss schistosity 213/35. The excavation was interrupted for a long time and a new design of “cover and cut” was chosen to restore the failure (Chatziangelou and Christaras, 2005).

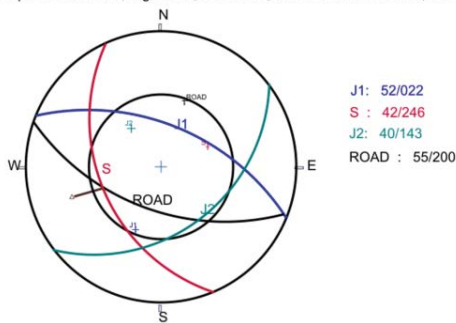
Asprovalta tunnel II, Right bore, 2nd bench, CH.10+510-CH.10+520, GNEISS

Considering the stability of the slope, gneiss formation, being placed between ch.10+505 and ch.10+556 of the 3rd bench, might slide along the direction of schistosity 213/35. The same formation, being placed between ch.10+510 and ch.10+520 of the 2nd bench, might slide along the direction of schistosity 246/42 (Fig.16). There was a part of completely weathered gneiss, being placed between ch.10+670 and ch.10+680 of the

Fig. 16. Potential sliding in gneiss along the 2nd bench, between ch.10+510 and ch.10+520.

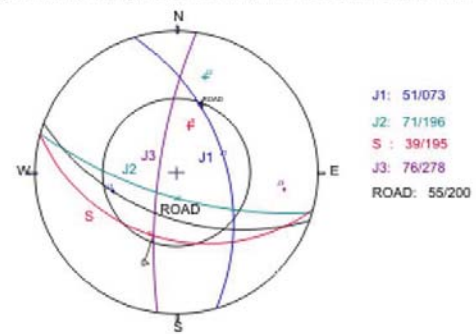
Asprovalta tunnel II, Right bore, 2nd bench, CH.10+600-CH.10+640, MARBLE

2nd bench, which might slide along the direction of the section being formed by schistosity 229/48 and joints 169/53 or 125/85. Marble formation, being placed between ch.10+600 and ch.10+640 of the 2nd bench, might slide along the direction of the section being formed by schistosity 195/39 and joints 278/76 (Fig.17, 18).

Fig. 17. Potential sliding in marble, along the 2nd bench, between ch.10+600 and ch.10+640.

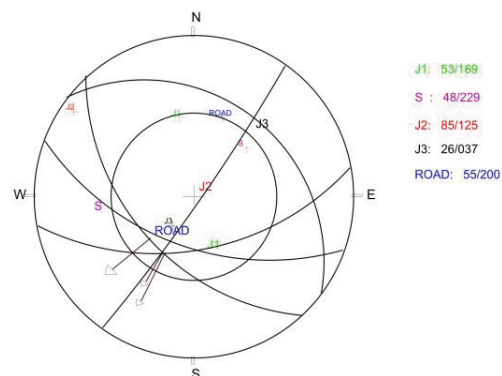
Asprovalta tunnel II, Right bore, 2nd bench, CH.10+670-10+680, COMPLETELY WEATHERED GNEISS

Fig. 18. Potential sliding in complete weathered gneiss, along the 2th bench, between ch.10+670 and ch.10+680.
