Scientific Annals, School of Geology, Aristotle University of Thessaloniki Proceedings of the XIX CBGA Congress, Thessaloniki, Greece	Special volume 99	491-501	Thessaloniki 2010
--	-------------------	---------	----------------------

THE IMPACT OF LANDSLIDES ON THE LANDSCAPE EVOLUTION ON THE ISLAND OF ANDROS

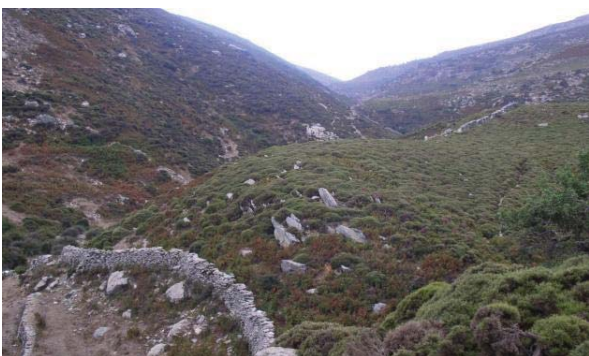
Photo 1. The foot of Vourkoti slide (photo looking upstream).

The old landslide in the Vourkoti torrent (Photo 1) is a characteristic example of such phenomena. The part of the valley that is in the form of a small plain can be seen in the lower left-hand side of photo 2a, while before and next to it, the course of the current is much steeper (Photo 2). These phenomena are frequent in the central part of the island, as this part has been mainly affected by the previously described geomorphologic evolution.

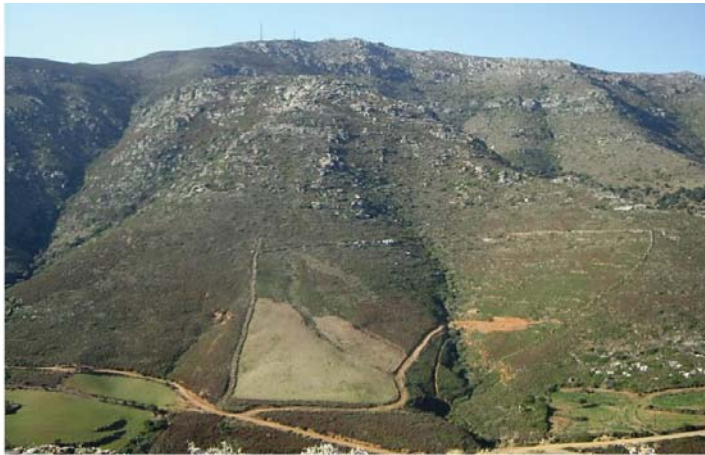
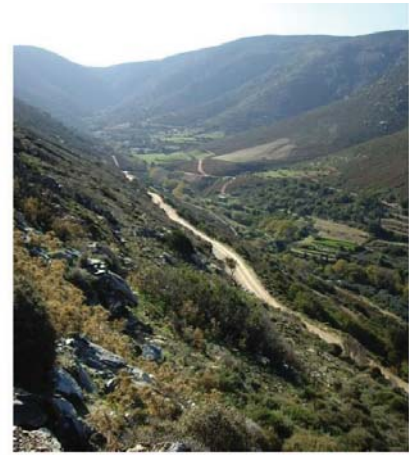
Photo 2. Vourkoti hydrographical axis in the central part of the island. A close view of the displaced part of the slope is shown in photo (a), while the change in the inclination of the current due to an old massive landslide is obvious in photo (b).

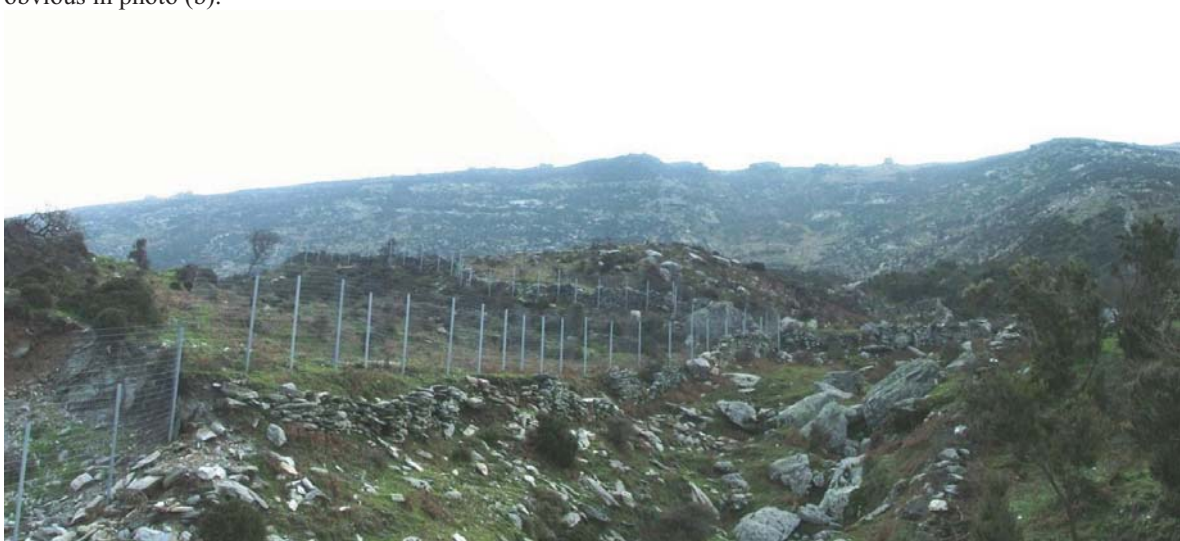
Photo 3. View of “petrified” younger landslide, on a slope in the central part of the island.

As the groundwater regime underwent changes in its courses due to the continuing landscape evolution, some of those places became dry, while in others the groundwater increased in quantity and was discharged in the form of continuous springs. Thus, the secondary factors affecting the slope failures in the first ones, such as groundwater movement and fluctuations, its additional load as well as the high pore water pressure, were eliminated, and the landslides were “petrified” as those in the northern slope of the Petalon Mountain, namely between the villages of Vourkoti and Arni (Photo 3).

In a next stage, the intensive fractured rock masses with a chaotic structure helped in the materialization of the intermediate type of landslides, which contribute in turn in the recent landscape evolution. These loose and disturbed rock masses were very sensitive to landslide triggering factors, such as groundwater (additional load, high pore water pressure, etc). Thus, large slope movements were triggered inside those masses, creating ladder-like landscapes, some sites of which are now the founding ground of main villages, because of water existence in the form of springs and the gentle inclination of the slopes (Photo 4). In some of these sites, a number of landslides are periodically reactive, causing severe problems to residential areas, while in others they are “petrified” as the landscape evolution has caused changes in groundwater courses (Photo 3).

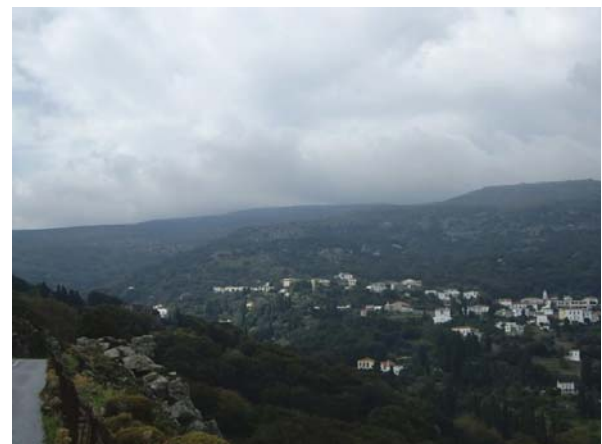
Another such type of failure is the earth or debris flows, the presence of which is mainly evident in Photo 4. A general view of Apoikia village, where Sariza Springs exist. In the slope parts above and in the village area, landslide is manifest.

By contrast, in the sites where the groundwater level rose, the landslides of the second group became more intensive, resulting in active landslides present to this day. The most characteristic example of such slope movements are the landslides in the slopes between the villages of Apoikia and Stenies. In that zone of older landslides, the existence of Sariza Springs with high groundwater discharge intensifies the action of the factors affecting younger landslide manifestation (Photo 4).

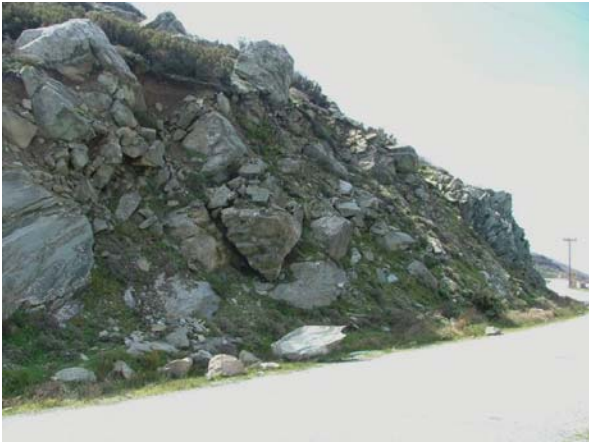
Photo 5. The chaotic type of disturbed geological formations.

These new slope failures increase the looseness and disturbance of the geological formations and so the rock mass displaces a chaotic form in the whole zone of slopes from Apoikia to Stenies (Photo 5).

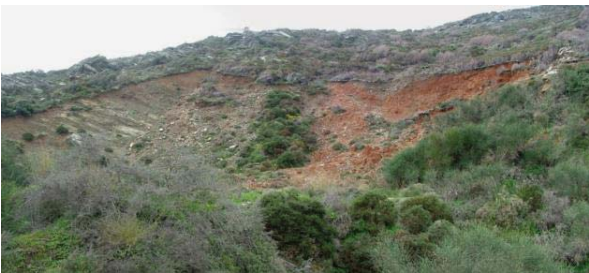
Photo 6. Rotational slide in weathering mantle of schist formations.

Small rotational slides are the main types of such slope movements (Photo 6). They manifest in natural or artificial slopes that are covered by rather thick weathering mantle, the remolded materials which locally cause the temporary obstruction of traffic (Photo 7).

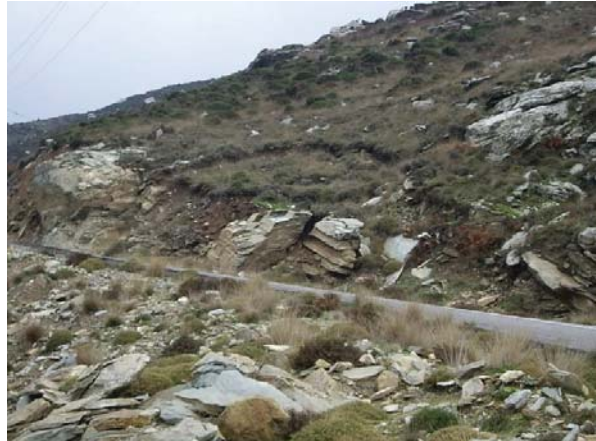
Photo 7. Rotational slide in weathering mantle of schist formations, with marble intercalations, affecting a road axis.

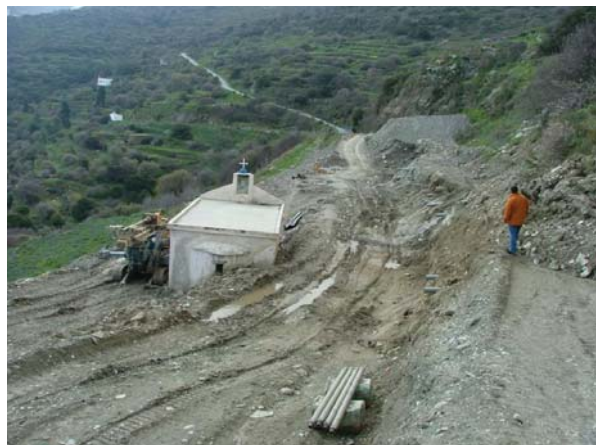
Photo 8. Destruction of a road and small church located downslope, near the village of Kochilou.

Sometimes these landslides are more serious as the weathering mantle is thicker and the slope steeper. In these cases, the effects on construction are severe and remedial measures very expensive (Photo 8 & 9).

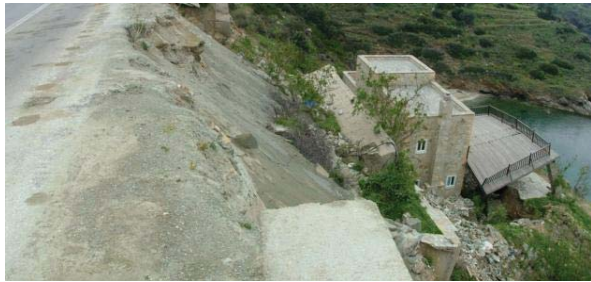
Photo 9. Severe damages of a villa built downslope from the road connecting the villages of Batsi and Gavrion. The cast in situ piles for the protection of the road pavement are also distinguished.

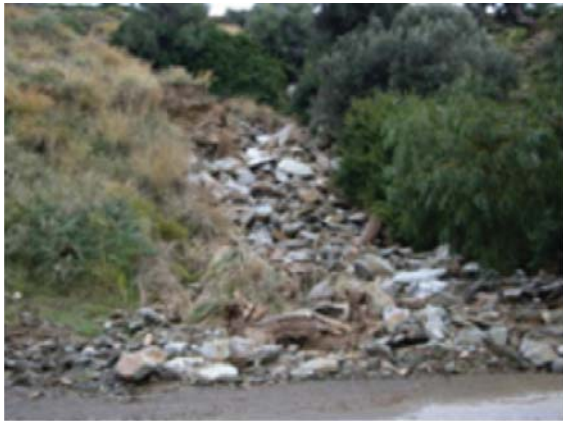
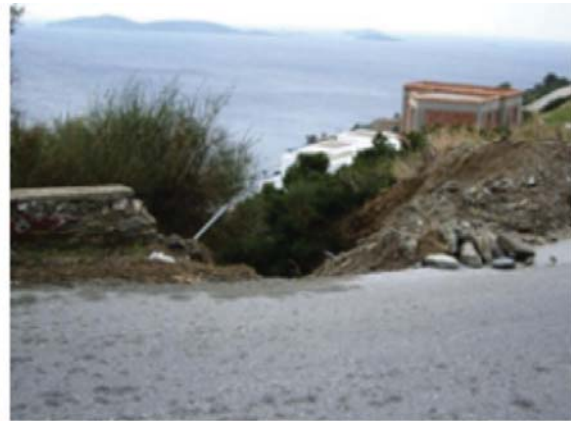
Photo 10. Obstruction of road pavement (a) and destruction of its protective wall (b), near the Kipri village.

their shear resistance and increases their load. The downward movement of these materials, mainly along hydrographic axes, causes the obstruction of the main road axes and damages their protective walls at locations where the road crosses their course (Photo 10).

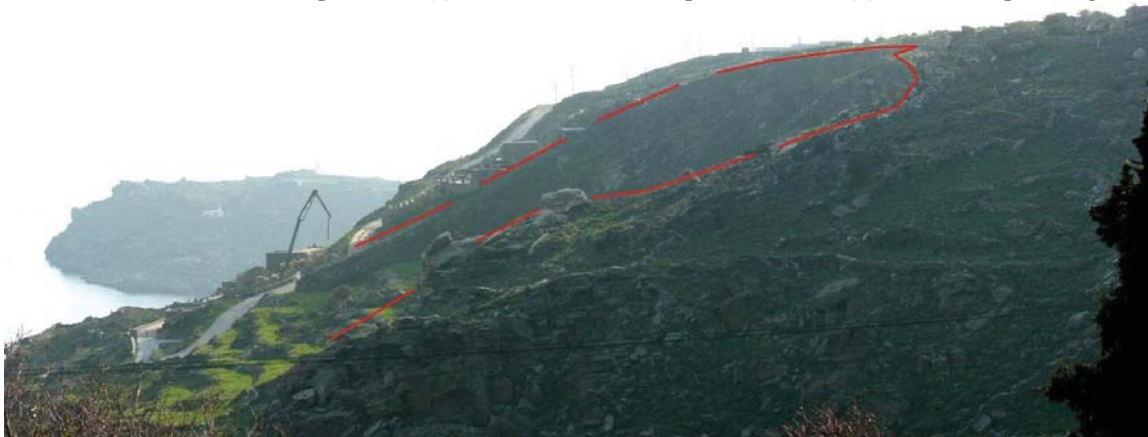
Photo 11. Rock falls and rock slide in the Aprovatou village area.

Rock falls and rockslides are also another type of synchronous landslides that are manifested in steep rock slopes. A good example of this type is the slope failure in Aprovatou village (Photo 11) where the tectonic action has favoured high fracture of the rock mass. Finally, the wave erosion undercut the slopes in certain coastal areas where the formations are fractured by the tectonic, causing slab slides or rock falls (Photo 12).

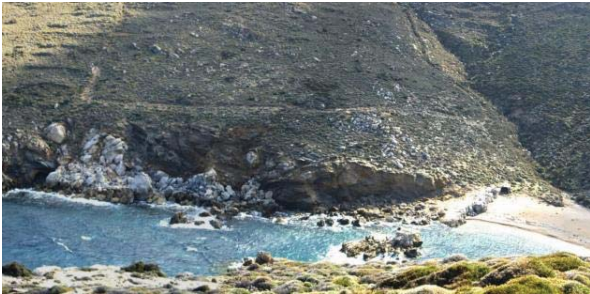
Photo 12. Rock falls and slab slide due to wave erosion, in a northern coast of the island.
